Oxford® Slings
Additional Sling and Safety Information

Following Medical Device Alerts on other manufacturers' slings, it is important that users of Oxford slings always follow the instructions in the user manuals provided with each sling and also the labels which are stitched into each sling.

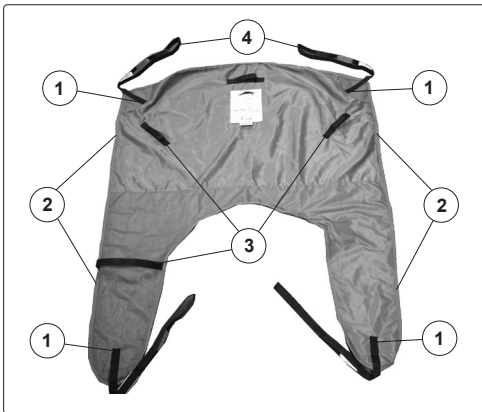
Example of an Oxford sling:

Key areas for inspection include:

1. Sling strap attachment point
2. Seams
3. Handle attachment points
4. End loops on sling straps

Inspection is required on all areas of the sling. The following information provides some guidance on key areas for inspection:
